# Genesee-Finger Lakes Regional Local Bridge Vulnerability Assessment

**Final Report**

**June 2019**

WSP USA Inc.  
50 Lakefront Blvd., Suite 111  
Buffalo, New York 14202

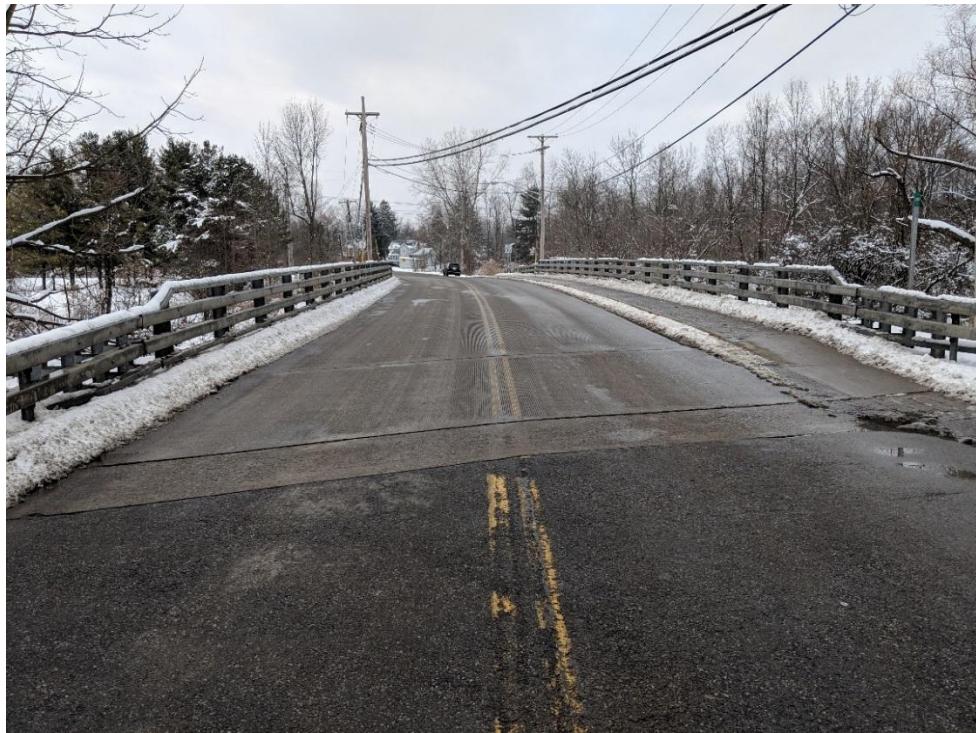
(looking west): BIN 2210840 – Monolithic concrete deck and sidewalk.

At the time of the visit, the integral wearing surface appeared to be in good condition with no evidence of concrete deterioration. The galvanized steel railing was also in good condition with no signs of damage or defects. The concrete deck fascia and underside of the overhangs appeared to be in good condition on both sides of the bridge. The adjacent prestressed concrete box beams were in good condition with no signs of hairline cracking, rust stains, or efflorescence. The bridge substructure was in fair to good condition and appeared to be stable. The concrete solid pier had evidence of previous spall repairs and a full length rehabilitated bridge seat. The concrete abutments and wingwalls exhibited minor deterioration with localized spalling. Evidence of a reconstructed bridge seat and spall repairs was also apparent at the abutments. Spalling can be remedied through localized patching techniques.

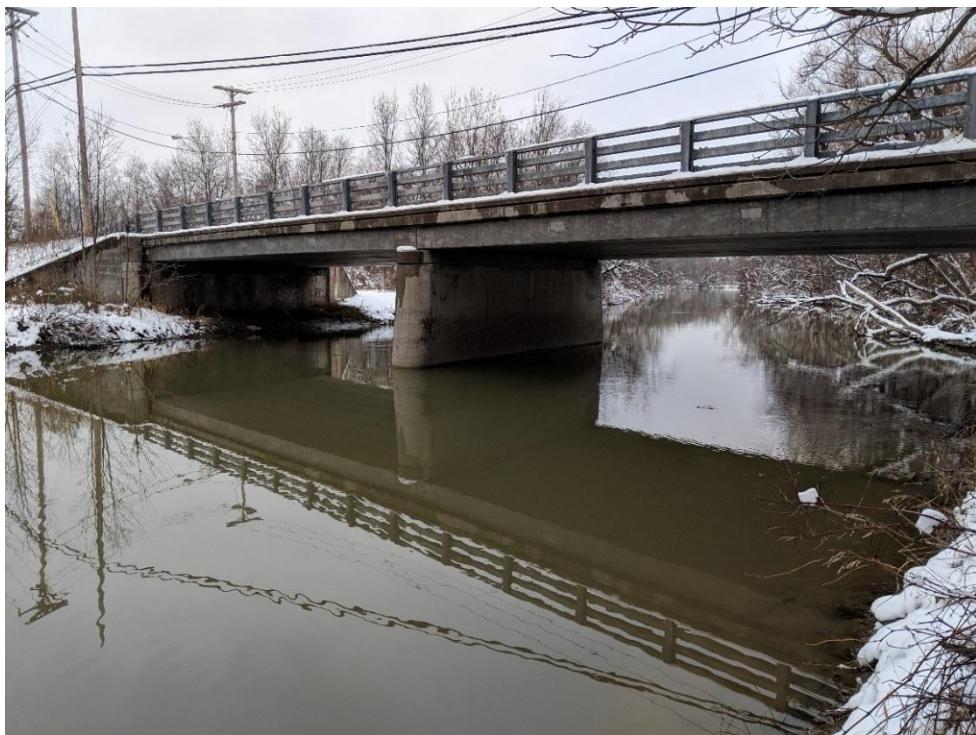
(looking north, upstream side): Two-span adjacent prestressed concrete box beams.

Tonawanda Creek flows south to north. At the location of the bridge, the flow of water is not constrained, so there is little risk of contraction scour. While an in-depth investigation of scour issues is out of the scope of this assessment, local scour could occur over time around the pier. Contraction scour did not appear to be an issue. The foundations appeared to be stable, but there is some erosion occurring at the abutments due to runoff. Large stones were placed on the abutment slope to stabilize the soil, but erosion appeared to be continuing. The shoreline near the bridge is also eroding, which may be due to high water levels in the creek. Some damage to the shoreline and movement of the shoreline was evident at the bridge. The latest available inspection report (June 2015) in the National Bridge Inventory noted this erosion along the bank but reported that the bridge foundations were determined to be stable for scour ([link: https://bridgereports.com/1383841](https://bridgereports.com/1383841)). The bridge's generous freeboard, even at high water allowed plenty of room for the passage of large debris. Finally, overtopping risk appeared to be very low at this bridge.

The following preliminary recommendations for countermeasures may be considered to make the bridge less vulnerable to hazard events based on the limited information available, the cursory nature of this Assessment, and FHWA recommendations outlined in Hydraulic Engineering Circular No. 23, *Bridge Scour and Stream Instability Countermeasures: Experience, Selection, and Design Guidance* (HEC-23):

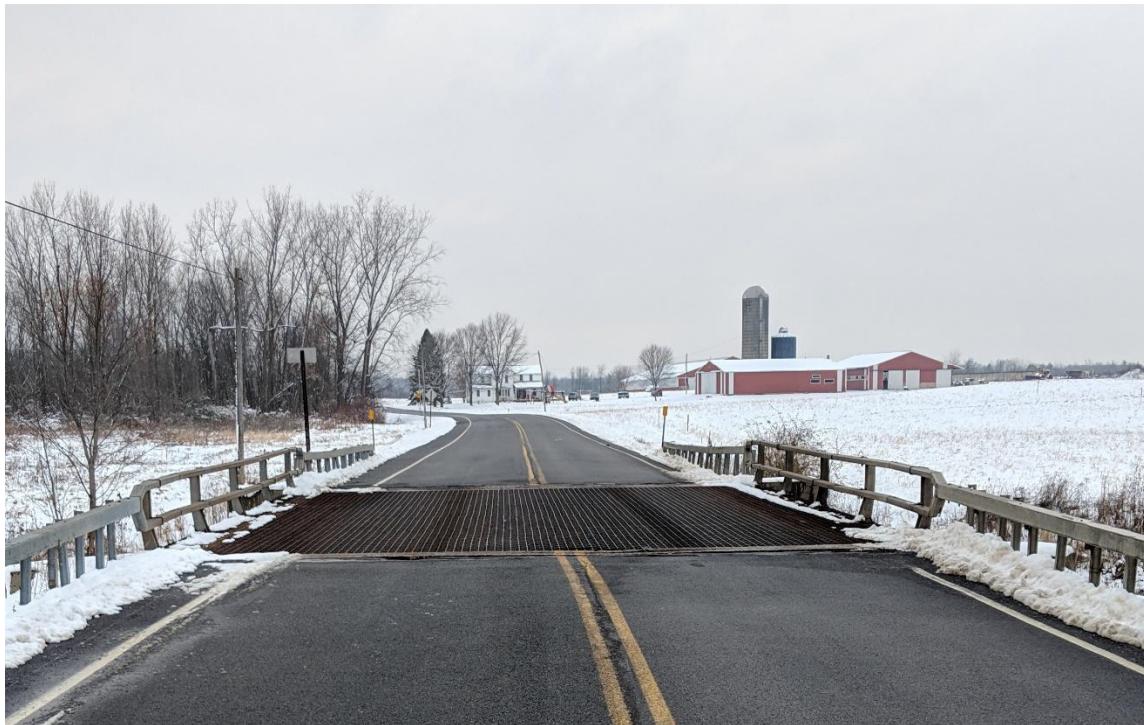
(looking north): BIN 3315450 – Open steel grid deck.

At the time of the visit, the open steel grating deck had minor wear to the serrations and was moderately rusted throughout, but without any appreciable section loss, and was in overall fair condition. The metal railing was in fair condition with isolated areas of coating failures and rusted thru holes in the lower rails. The steel girders exhibited widespread surface corrosion, particularly at the interior girders due to the open deck, but no section loss was evident and the overall condition was fair. The bridge substructure was in poor condition. The abutment stemwalls exhibited severe deterioration with spalling, efflorescence, and horizontal and vertical cracks, particularly at the north abutment. The backwalls in between the girders were covered with wooden forms, possibly to prevent the loss of fill material behind the abutments. There were areas of surface depressions in the approach pavement along the joint where the steel grid deck begins, further evidence that fill could be eroding behind the backwalls. Debris had accumulated on the bridge seats, surrounding the bearings and contributing to their deterioration. The backwalls that were beyond the girders and atop the wingwalls had severe spalling along the horizontal joint aligned with the bridge seat and appeared to be unstable.

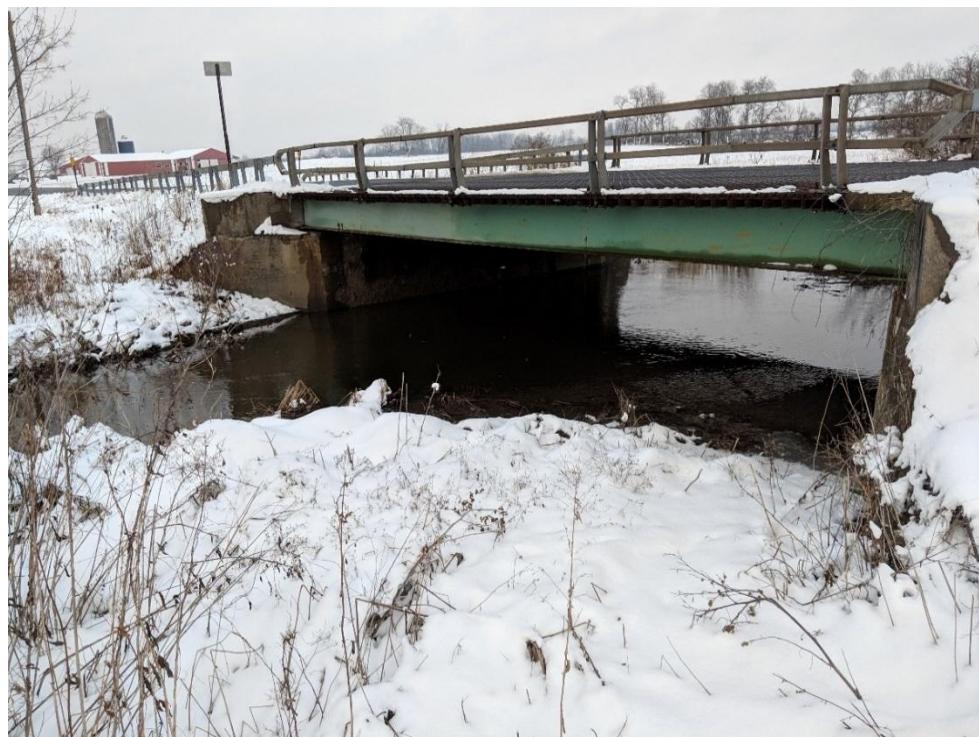
(looking east, downstream side): Single span steel multi-girder bridge.

Murder Creek flows east to west at the location of the bridge. The flow of water is not constrained at the bridge, so there is little risk of contraction scour. While an in-depth investigation of scour issues is out of the scope of this assessment, local scour could occur over time along the abutments. Contraction scour did not appear to be an issue. Some damage to the shoreline and movement of the streambed was evident at the bridge. The latest available inspection report (May 2015) in the National Bridge Inventory noted this erosion along the bank but reported that the bridge foundations were determined to be stable for scour ([link: https://bridgereports.com/1388029](https://bridgereports.com/1388029)). The bridge's freeboard appeared to allow sufficient room for the passage of large debris. Finally, overtopping risk appeared to be very low at this bridge.

The following preliminary recommendations for countermeasures may be considered to make the bridge less vulnerable to hazard events based on the limited information available, the cursory nature of this Assessment, and FHWA recommendations outlined in Hydraulic Engineering Circular No. 23, *Bridge Scour and Stream Instability Countermeasures: Experience, Selection, and Design Guidance* (HEC-23):

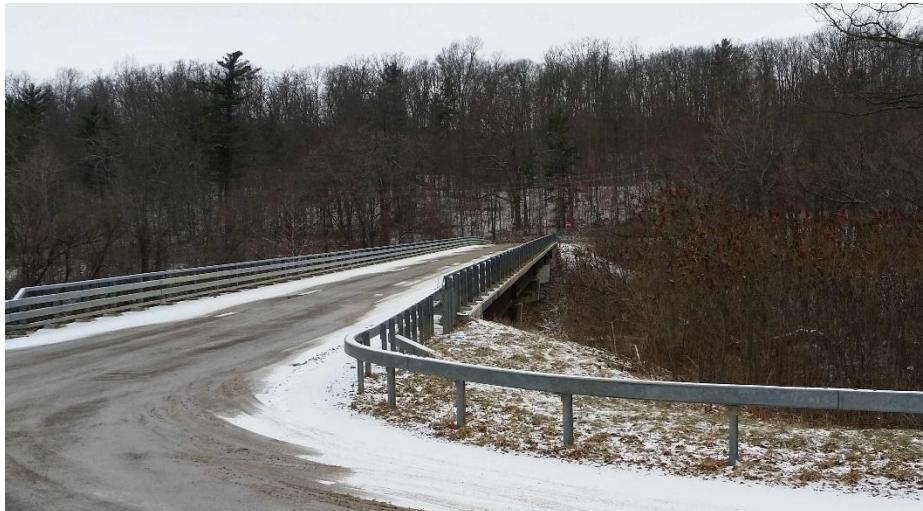
*(looking northwest): BIN 3319860 – asphalt wearing surface on stay-in-place formed concrete deck.*

At the time of the visit, the integral concrete wearing surface was in good condition. The galvanized bridge railing was in good condition. The bridge concrete deck appeared to be in good condition. The weathering steel superstructure appeared to be in good condition. The concrete bridge piers appeared to be in fair condition with map cracking, staining from the weathering steel, and evidence of previous spall repairs having already been completed. The concrete abutments appeared to be in fair condition with widespread failure of the coating-type sealer that had been applied to the surfaces. The abutments exhibited efflorescence and rust staining at cracks, evidence of corrosion of embedded rebar. There was evidence of isolated spall repairs, particularly at the bridge seats.

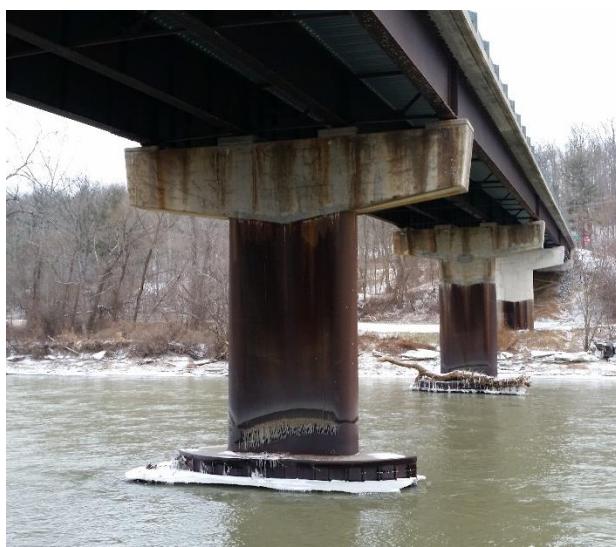
*(looking northwest, downstream side): Four-span bridge with three armored, hammerhead concrete piers and concrete abutments. Debris in channel, erosion of banks.*

The Genesee River flows south to north, and empties into Lake Ontario. At the location of the bridge, the flow of water is not constrained, so there is little risk of contraction scour. While in-depth investigation of scour issues is out of the scope of this assessment, local scour could occur over time around the piers. Contraction scour did not appear to be an issue. The foundations appeared to be stable, but there is some erosion occurring at the abutments due to runoff. Gabion baskets had been placed at the southeast abutment to protect the abutment from erosion. At the northwest abutment, rip-rap and diagonal timbers had been placed. It was unclear if these were placed significantly after construction of the bridge, or if they were placed more recently to arrest erosion, but erosion appeared to be continuing. The shoreline near the bridge is also eroding, which may be due to high water levels in the river. Some damage to the shoreline and migration of the shoreline was evident at the bridge. The latest available inspection report (May 2015) in the National Bridge Inventory noted the bank erosion and reported that the bridge foundations were determined to be stable for scour (link: <https://bridgereports.com/1388388>). The bridge's generous freeboard, even at high water allowed plenty of room for the passage of large debris. Finally, overtopping risk appeared to be very low at this bridge.

The following preliminary recommendations for countermeasures may be considered to make the bridge less vulnerable to hazard events based on the limited information available, the cursory nature of this Assessment, and FHWA recommendations outlined in Hydraulic Engineering Circular No. 23, *Bridge Scour and Stream Instability Countermeasures: Experience, Selection, and Design Guidance* (HEC-23):

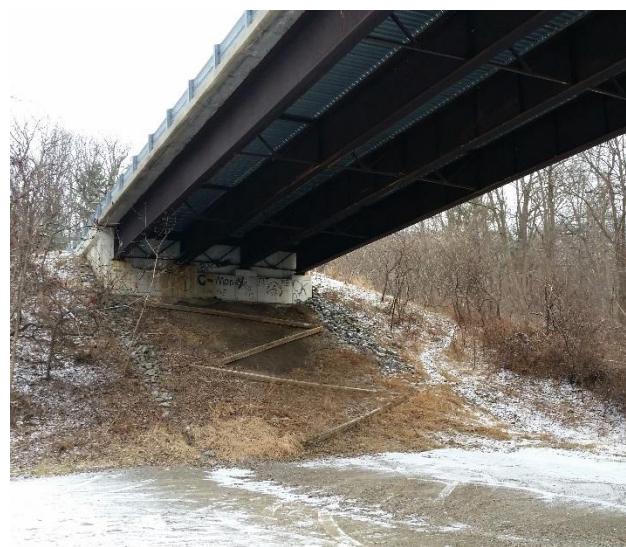
*(looking northwest): Steel stringers and girders. Slope stabilization.*

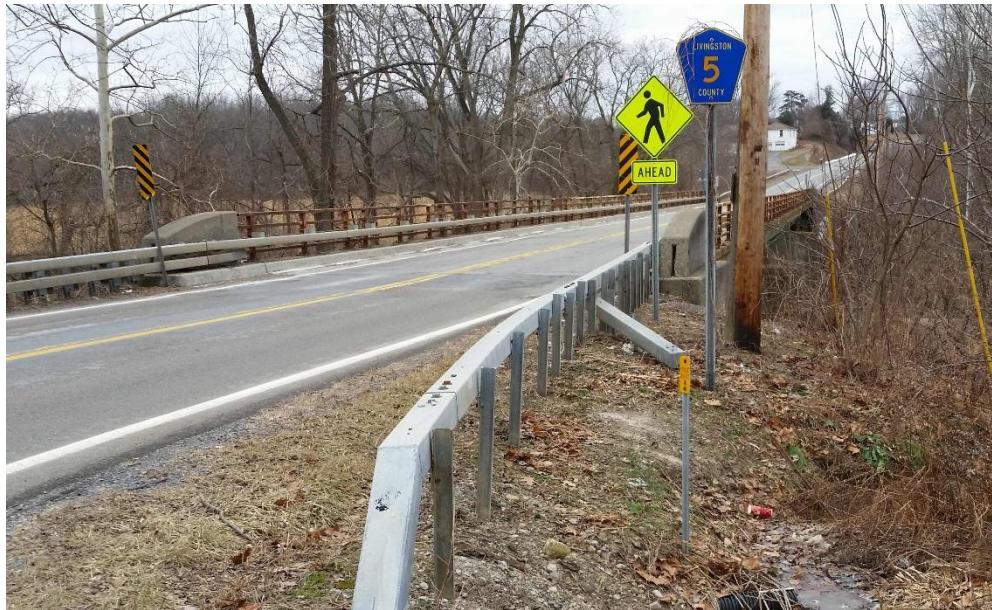
(looking west): BIN 3316240 – asphalt wearing surface on cast-in-place concrete deck.

At the time of the visit, the thin asphalt wearing surface was in poor to fair condition. The asphalt was so thin that it appeared that the original intent was for the concrete deck to be the surface. The coating system on the bridge steel railing was critical with total paint failure and widespread initiation of corrosion. The bridge concrete deck appeared to be in good condition based on what could be seen from underneath the bridge. The steel superstructure appeared to be in good condition with localized degradation of the components at faying surface and at scupper downspouts. The coating system on the bridge superstructure was in fair condition with widespread locations of minor paint failure. The concrete bridge piers appeared to be in good condition and stable. The concrete abutments appeared to be in fair condition with some efflorescence at isolated cracks. There was evidence of previous spall repairs, particularly at the bridge seats. The repairs appeared to be stable.

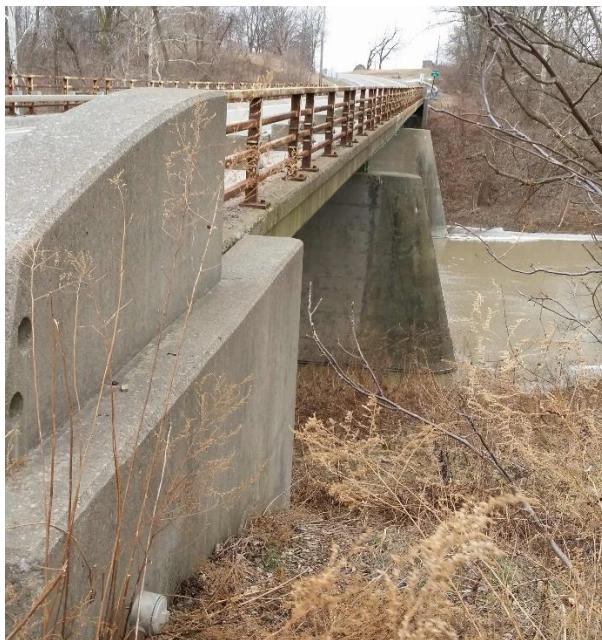
(looking east, upstream side): Three-span bridge with two solid wall concrete piers and concrete abutments.

The Genesee River flows south to north, and empties into Lake Ontario. At the location of the bridge, the flow of water is not constrained, so there is little risk of contraction scour. While in-depth investigation of scour issues is out of the scope of this assessment, local scour could occur over time around the piers. Contraction scour did not appear to be an issue. The foundations appeared to be stable, but there is some erosion occurring at the abutments due to runoff. Large stones were placed on the abutment slope to stabilize the soil, but erosion appeared to be continuing. The shoreline near the bridge is also eroding, which may be due to high water levels in the river. Some damage to the shoreline and migration of the shoreline was evident at the bridge. The latest available inspection report (December 2016) in the National Bridge Inventory noted the bank erosion and reported that the bridge foundations were determined to be stable for scour (link: <https://bridgereports.com/1388090>). The bridge's generous freeboard, even at high water allowed plenty of room for the passage of large debris. Finally, overtopping risk appeared to be very low at this bridge, as there were large fields adjacent to the bridge that were lower in elevation than the bridge superstructure.

The following preliminary recommendations for countermeasures may be considered to make the bridge less vulnerable to hazard events based on the limited information available, the cursory nature of this Assessment, and FHWA recommendations outlined in Hydraulic Engineering Circular No. 23, *Bridge Scour and Stream Instability Countermeasures: Experience, Selection, and Design Guidance* (HEC-23):

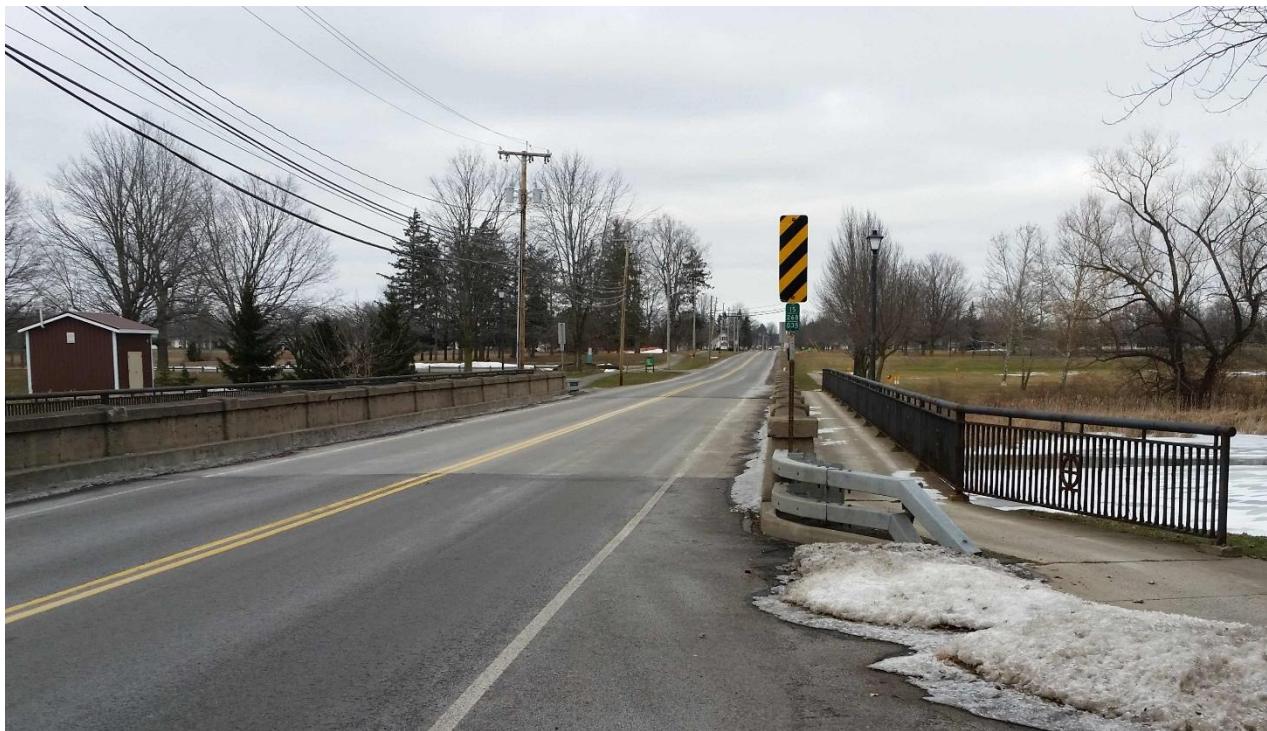
(looking north): BIN 3317290– asphalt wearing surface on cast-in-place concrete deck.

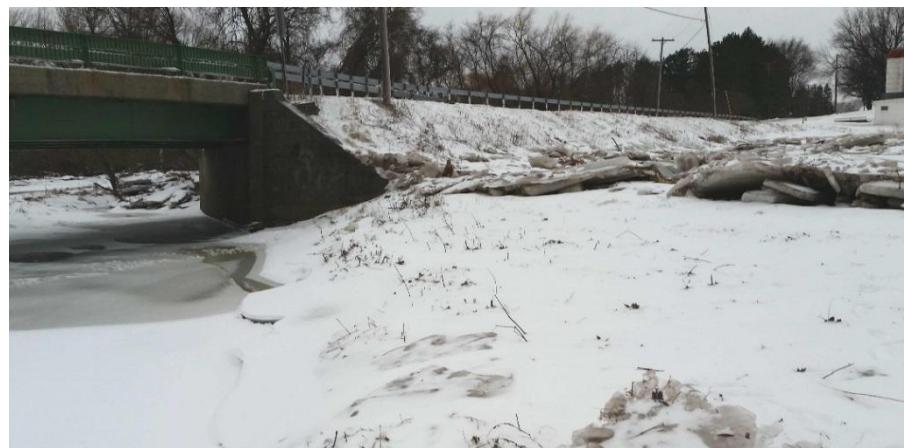
(looking north, downstream side): Evidence of ice jamming downstream (north east) of bridge.

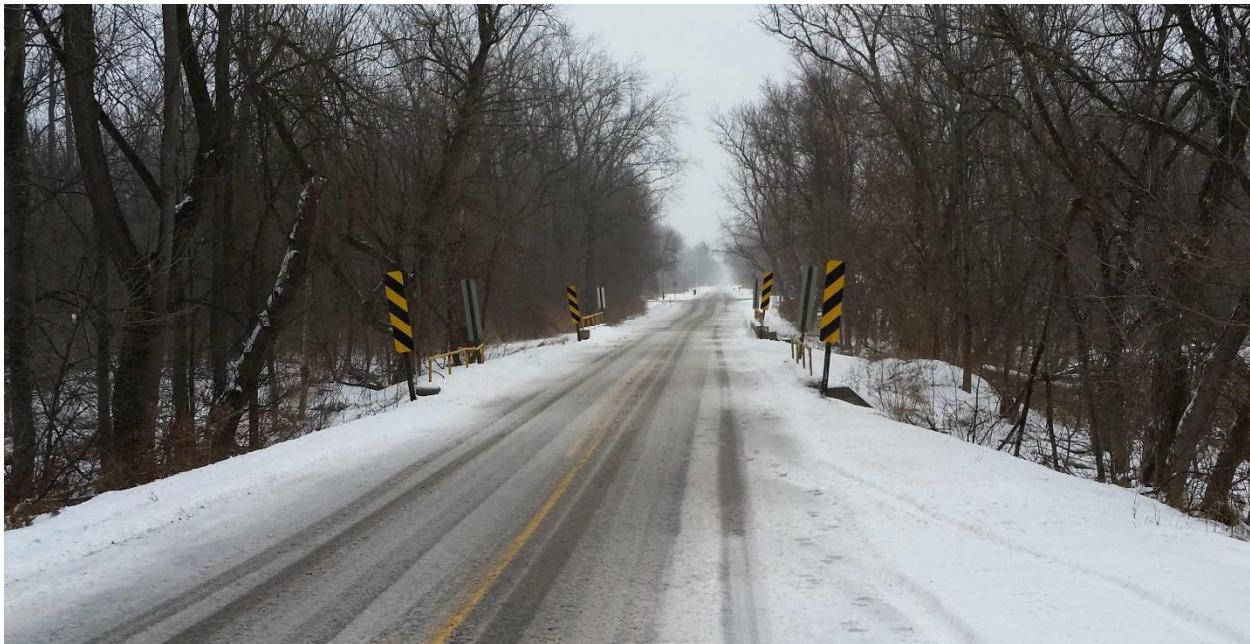
(looking north): BIN 3319170 – asphalt wearing surface on concrete deck (note the sub-standard guide rail protection).

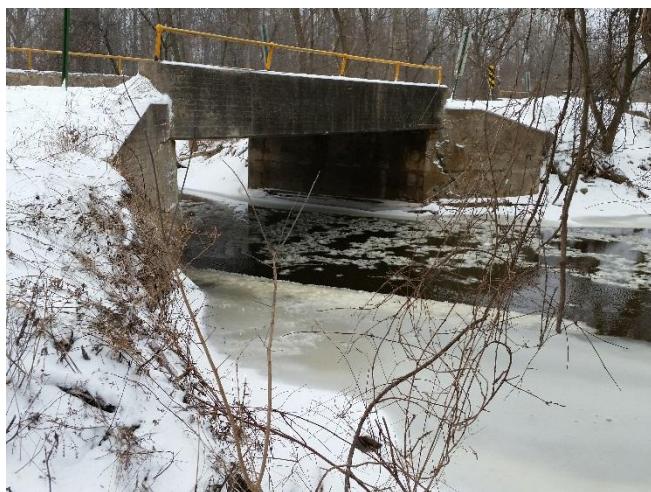
(looking south, upstream side): concrete abutments and wingwalls, constriction of flow.

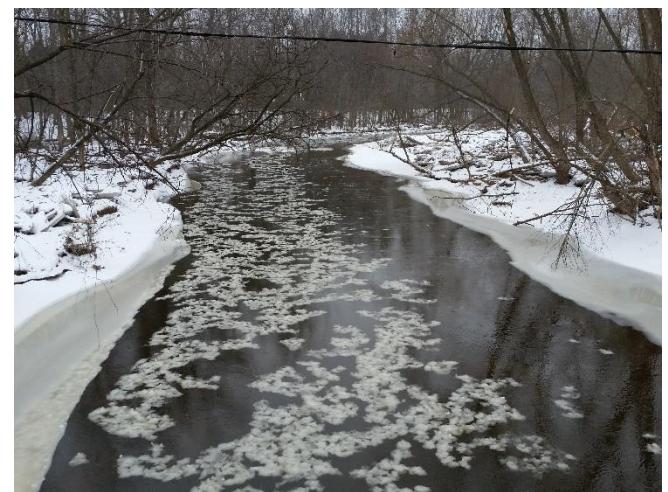
(looking west, upstream side): bank erosion, debris in channel, and evidence of ice jamming.

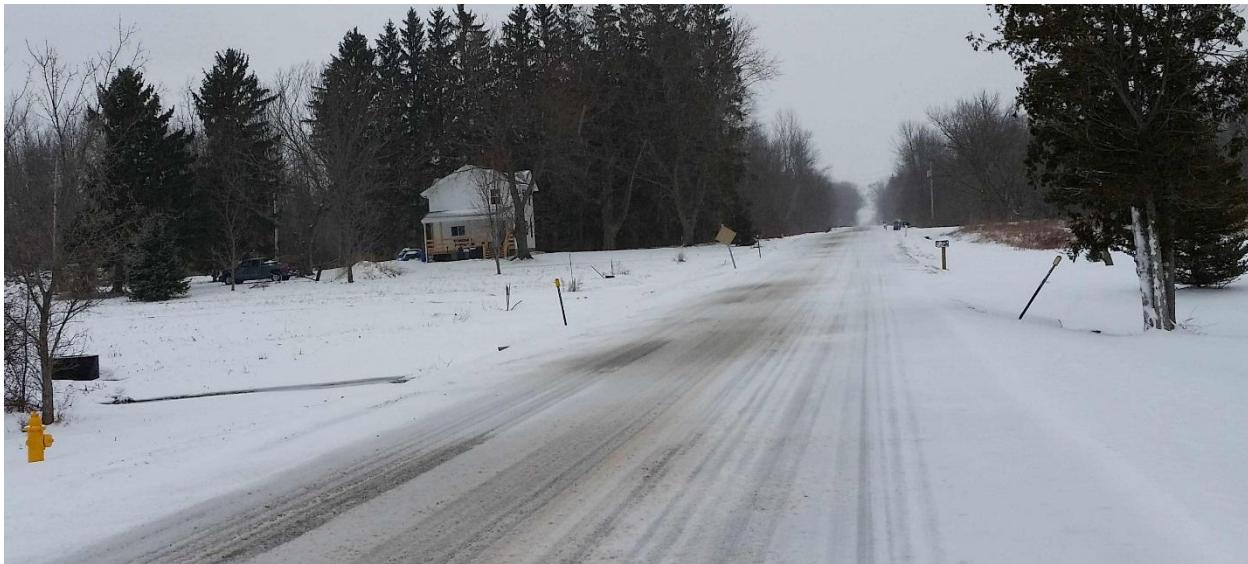
(looking north): BIN 3366340 – asphalt wearing surface on concrete deck (note the lack of guide rails).

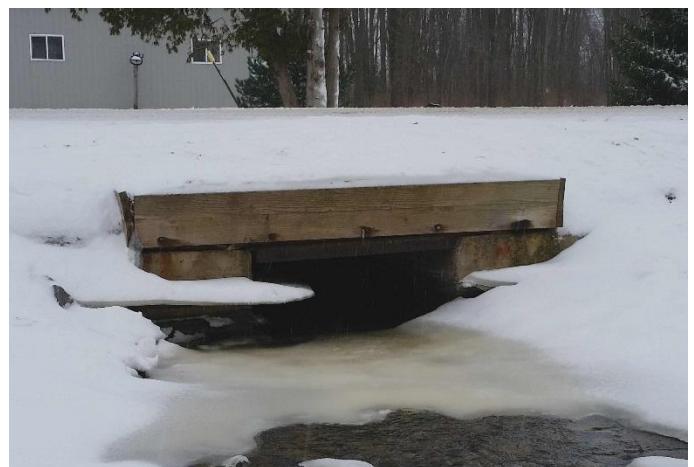
(looking east, upstream side): bank erosion, debris in channel, and evidence of ice jamming.

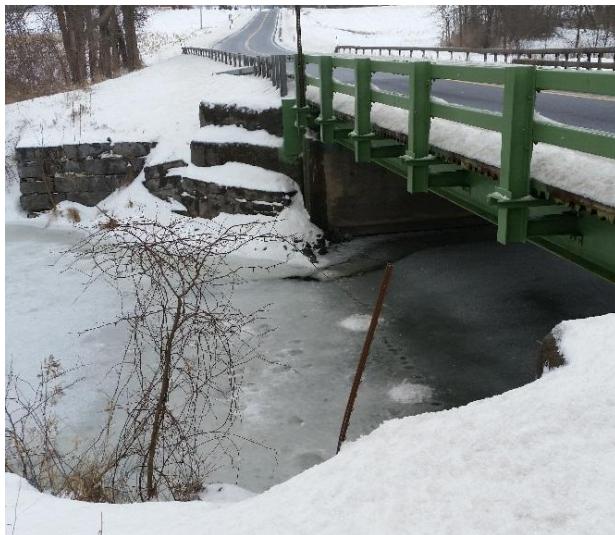
(looking east, downstream side): Some wingwall stones have fallen into the creek.

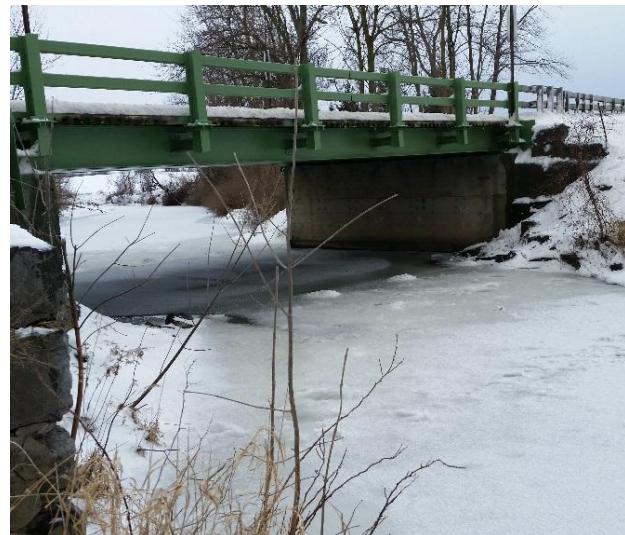
(looking west, downstream side): Some wingwall stones have fallen into the creek.
