Resolution 21-2 Accepting the NYSDOT Highway Safety Investigations Report as evidence of completion of UPWP Task 6232

**NYS DOT Safety Investigations
(UPWP #6232)**

HIGHWAY SAFETY INVESTIGATIONS REPORT

December 2020

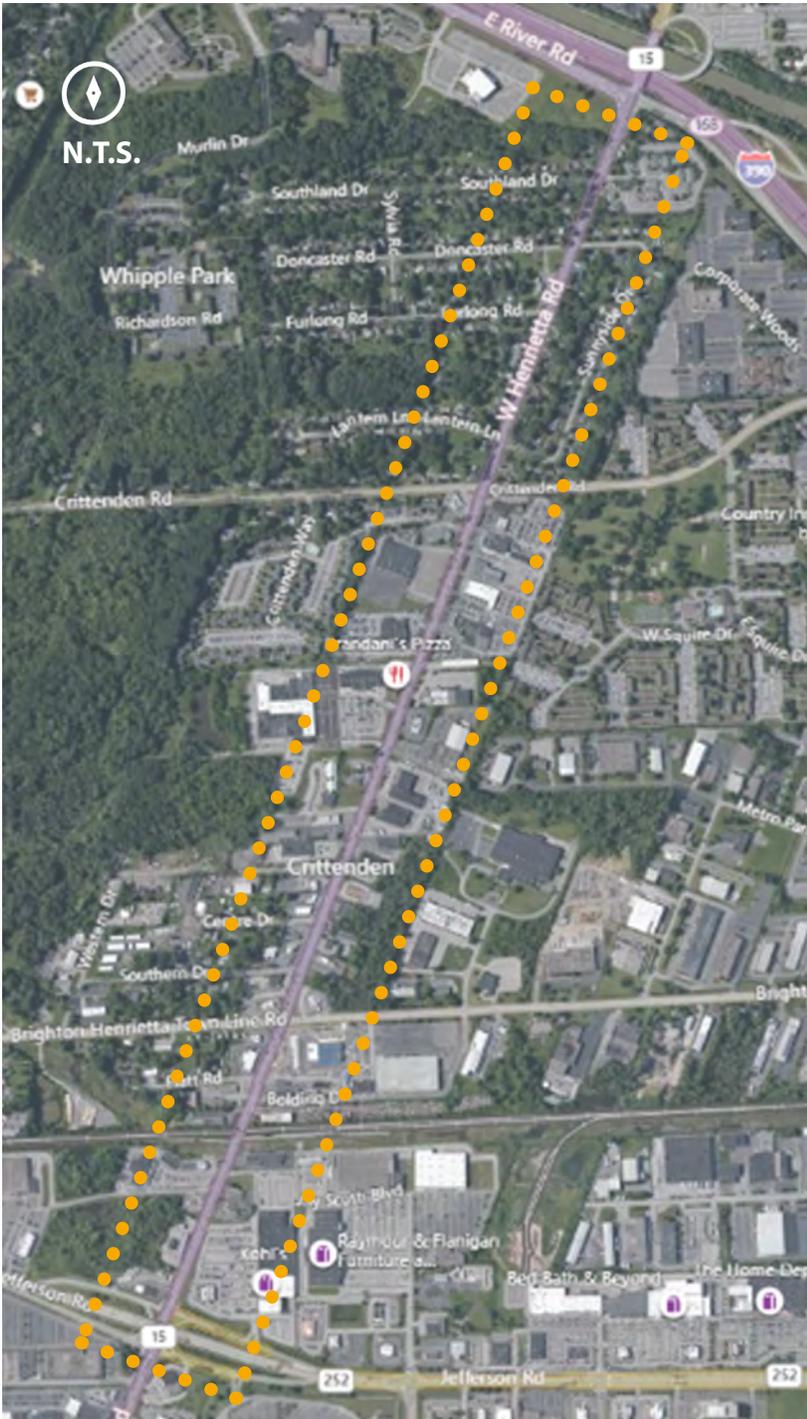
Figure 1: West Henrietta Road Study Area (source: Bing Maps)

West Henrietta Road (Route 15)

- 1.7-mile multi lane Urban Arterial
- Residential and Commercial Access
- Mixture of Signalized and Unsignalized Intersections
- Characterized by closely spaced commercial driveways, non-continuous sidewalk, and several transit stops.

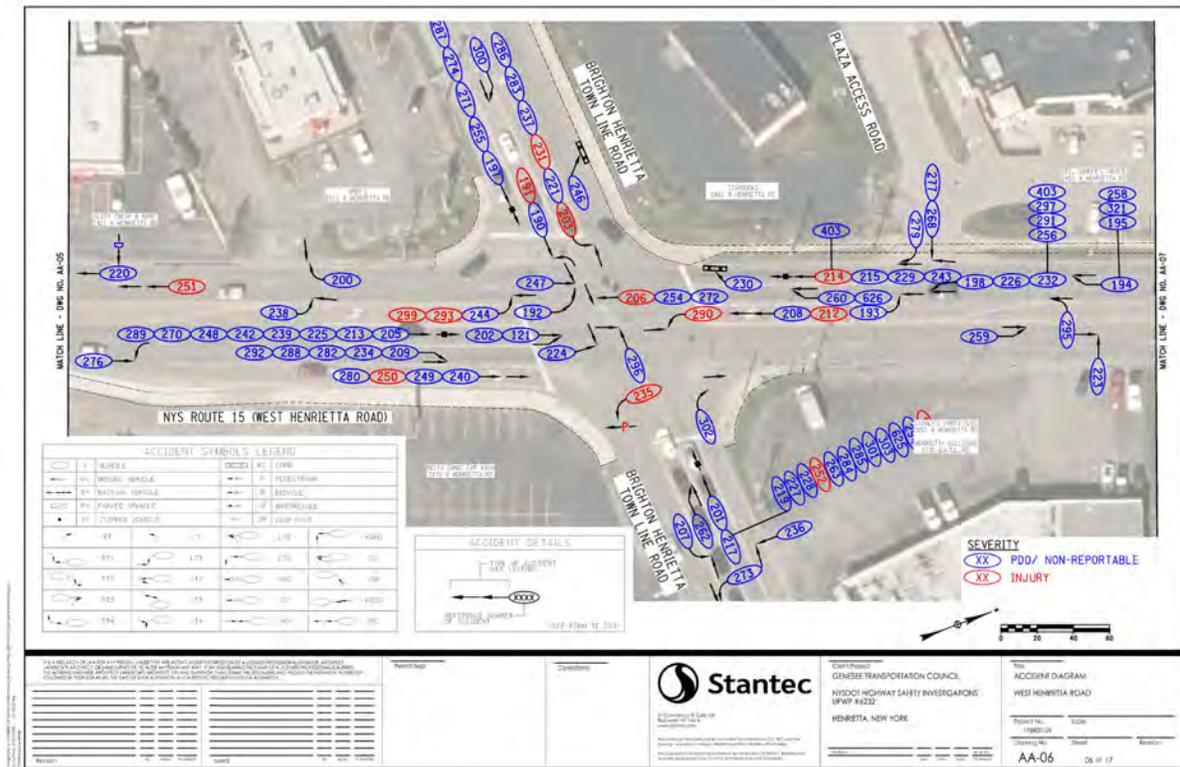
Figure 2: West Henrietta Road Collision Diagram

Within the study limits, both the signalized and unsignalized intersections were the largest contributors of crashes. Predominate intersection crash types included rear end, left turn, overtaking and right angle. Identified contributing factors for these crashes included visibility issues, distracted driving, aggressive behaviors, and excessive queuing. Corridor-wide, there were patterns related to courtesy crashes at various driveways. To validate these patterns and assess potential contributing factors, corridor field investigations were conducted during the weekday morning peak period (7:00 – 9:00AM) and during the evening peak period (4:00 – 6:00PM) on January 7, 2020 and February 11, 2020, respectively. These times reflect normal commuter periods and typically result in the heaviest traffic volumes and higher than average crash potential.

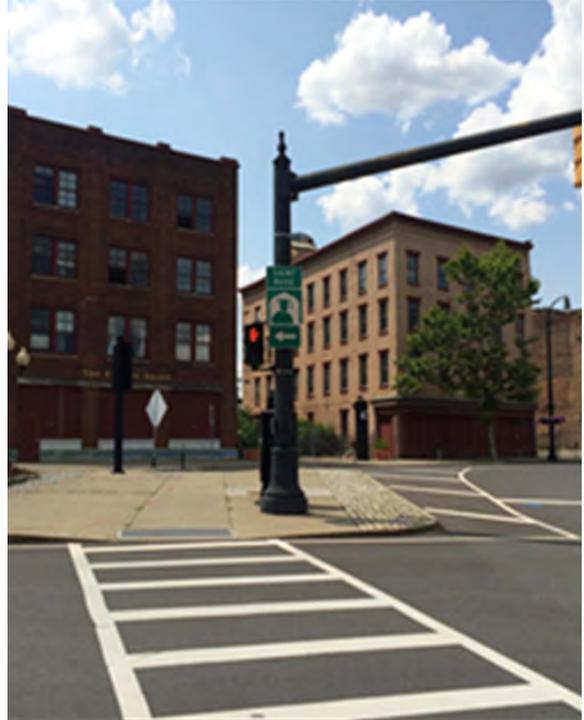
Example Pedestrian Facilities

- **Improve sidewalk networks, corridor lighting, and consider bicycle facilities per the most recent AASHTO guidance**
- **Upgrade pedestrian facilities to include hi-visibility crosswalks and pedestrian signals**
- **Evaluate the location of transit stops to support the Reimagine RTS Route 14 as well as RIT and U of R services**

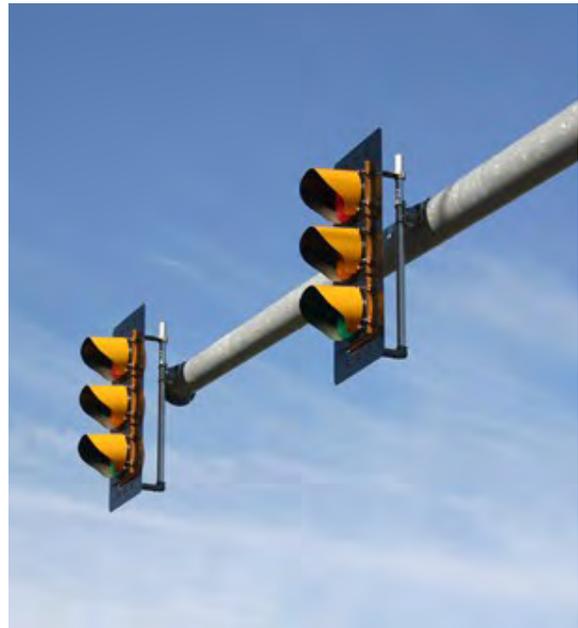
Example Signal Backplates

- **Install traffic signal backplates, additional signal heads, flashing yellow left turn arrows and/or replace existing signals with far side mast arm signals.**
- **Assess commercial driveway widths and evaluate side street alignments to improve visibility.**

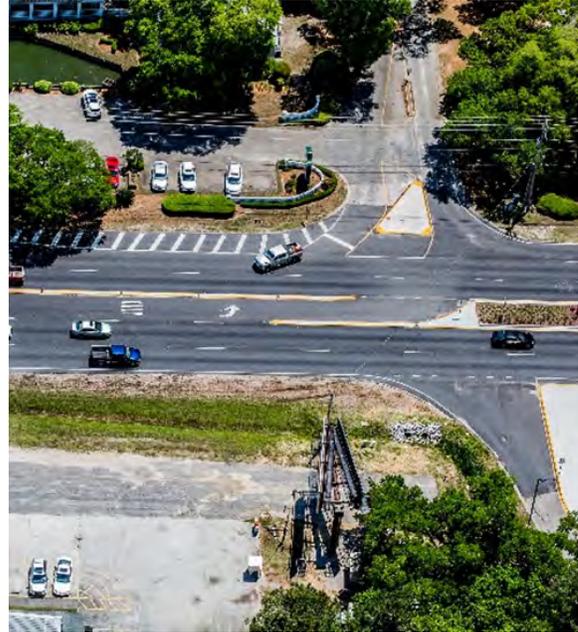
Example left turn restrictions

- **Traffic signal coordination to improve progression and minimize peak hour congestion**
- **Access management practices to address crashes associated with the high density of commercial driveways**
- **Limit left turns into or out of driveways and/or assess the feasibility of a center median in lieu of the center left turn lane**

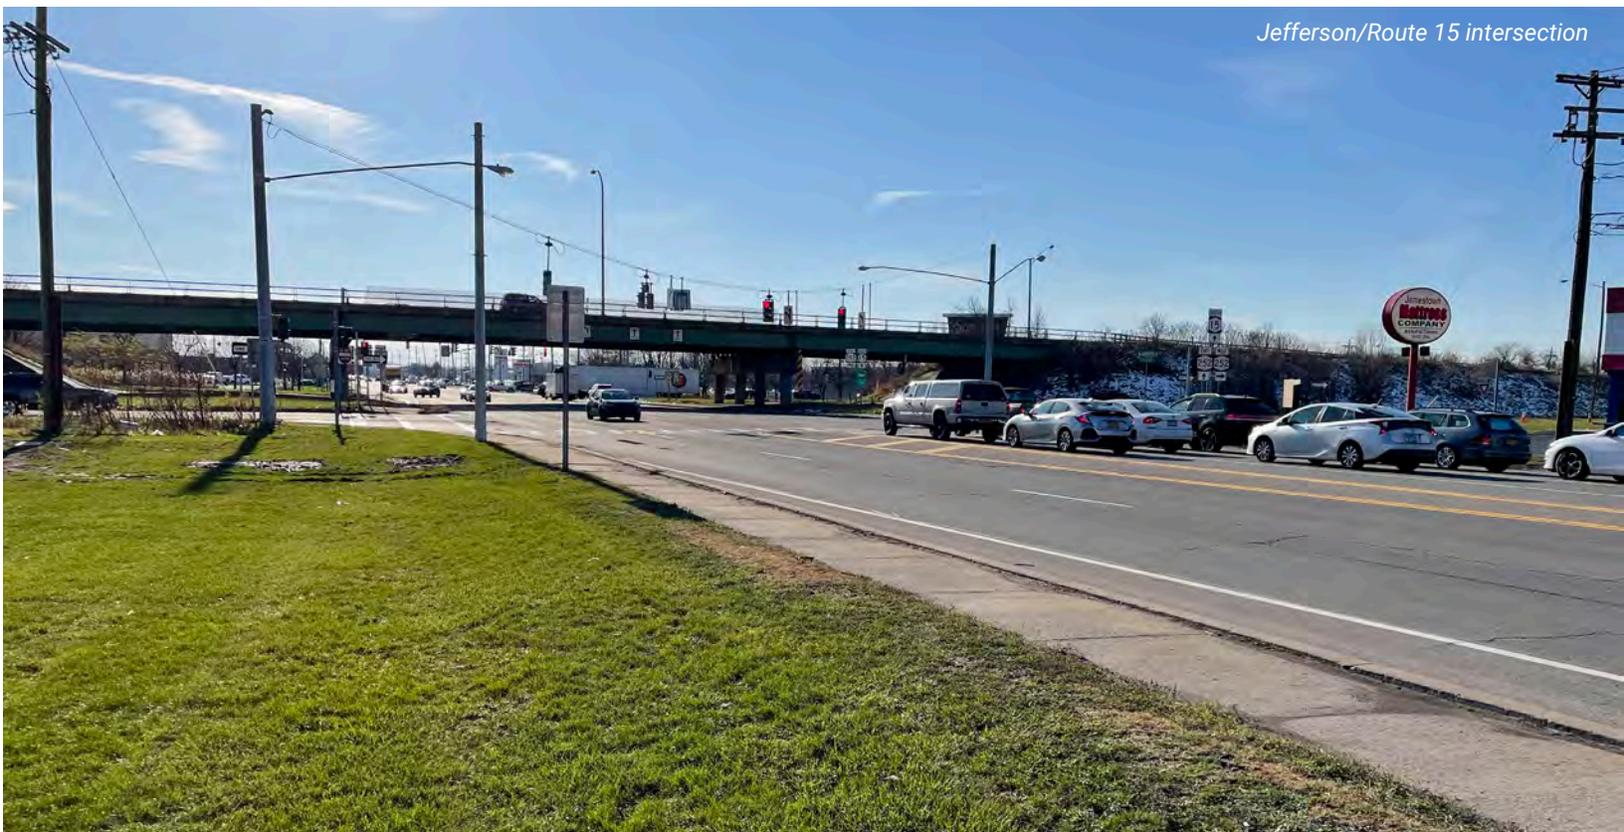
Jefferson/Route 15 intersection

Several future interchange configuration improvements at Jefferson Road were reviewed in light of the current crash patterns. These potential configurations include an at grade intersection (removal of the Jefferson Road Bridge), a Diverging Diamond interchange, a Median U-Turn interchange, and a Displaced Left turn intersection. While each option provides an opportunity to mitigate the current crash patterns, each also presents new challenges related to driver expectations, pedestrian safety, and operations.
